ARBORICULTURAL IMPACT ASSESSMENT REPORT

88 – 92 Botany Street, Carlton

Nasscon Pty Ltd

11th December 2019

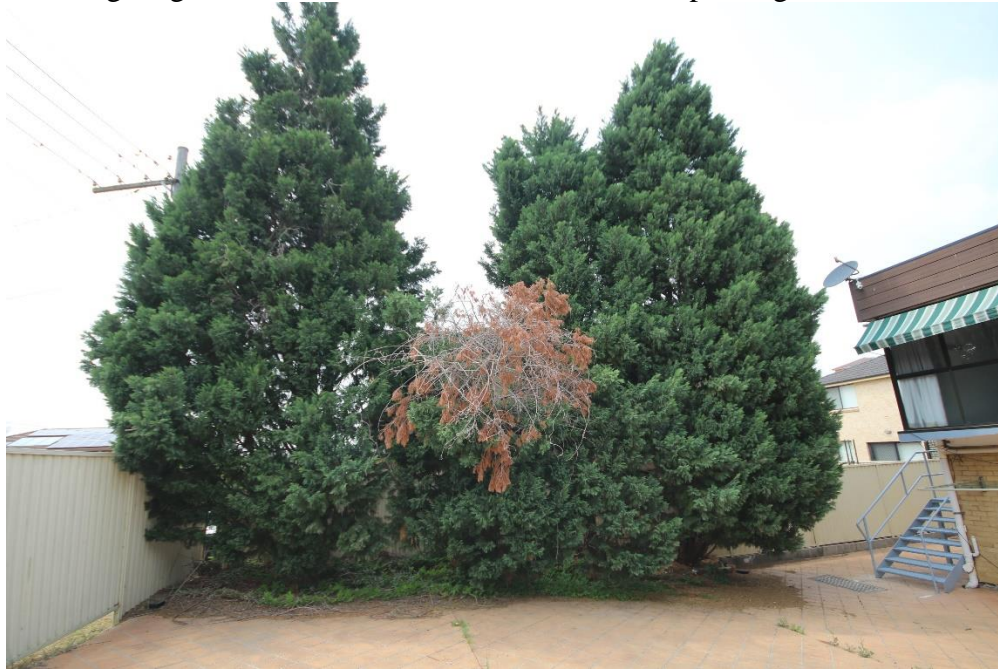
Plate 1 – trees 4 – 6

4. Tree 4, 5, 6 & 7 x *Cupressocyparis leylandii* are four trees located in the rear right of the site. Trees 4 & 7 show good vitality, but tree 5 shows canopy suppression and tree 6 has lost the top ½ of the trunk – refer plate 1. Tree 5 should be pruned to encourage regrowth. Note these trees for retention & pruning in the TMP;

- g) Prune Tree 5 to remove dead branches in compliance with AS 4373 – 2007 Pruning of amenity trees Section 3.17 & 7.2.2 Deadwooding;
- h) Install the following Tree Protection Measures around the retained street tree: Tree 2 & 10, tree protection measures shall be a temporary fence of chain wire panels 1.8 metres in height (or equivalent), supported by steel stakes or concrete blocks as required and fastened together and supported to prevent sideways movement. Existing boundary fences or walls are to be retained shall constitute part of the tree protection fence where appropriate. A sign is to be erected on the tree protection fences of the trees to be retained that the trees are covered by Council's tree preservation orders and that "No Access" is permitted into the tree protection zone;

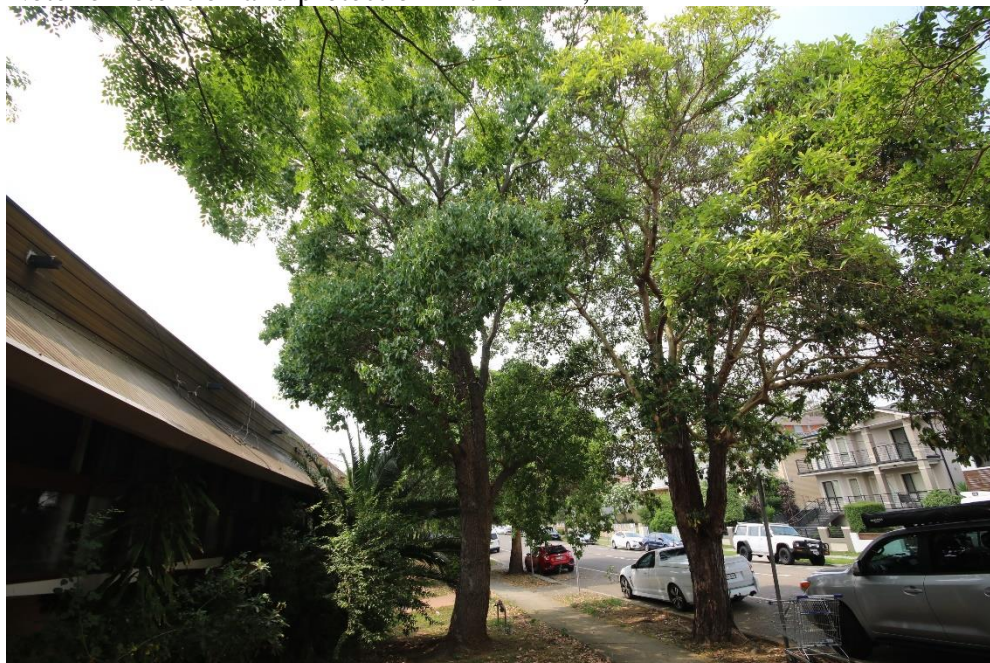
Plate 2 – tree 9

5. Tree 9 *Triadica sebifera* shows good vitality with an elevated form – refer plate 2. The new building will be constructed over the existing building footprint therefore the construction activity won't affect this trees stability and viability. No canopy pruning is required to undertake the development works. The walkway to the front door can be laid at grade to minimise potential root disturbance with a 50 – 80mm layer of aggregate to allow moisture and gaseous exchange with the root system. By employing these design considerations, the retention of this tree will be achieved. Note for retention and protection in the TMP;

- i) Trunk protection shall consist of a padding material such as hessian or thick carpet underlay wrapped around the trunk. Timber planks (50mm x 100mm or similar) shall be placed over the padding and around the trunk of the tree at 150mm centres. The planks shall be secured with 8-gauge wire or hoop steel at 300mm spacing. Trunk protection shall extend a minimum height of 2 metres: Trees 2, 9 & 10 – refer Annexure D;

- j) Install the following Tree Protection Measures around the retained trees on site: Tree 9, tree protection measures shall be a temporary fence of chain wire panels 1.8 metres in height (or equivalent), supported by steel stakes or concrete blocks as required and fastened together and supported to prevent sideways movement. A sign is to be erected on the tree protection fences of the trees to be retained that the trees are covered by Council's tree preservation orders and that "No Access" is permitted into the tree protection zone;

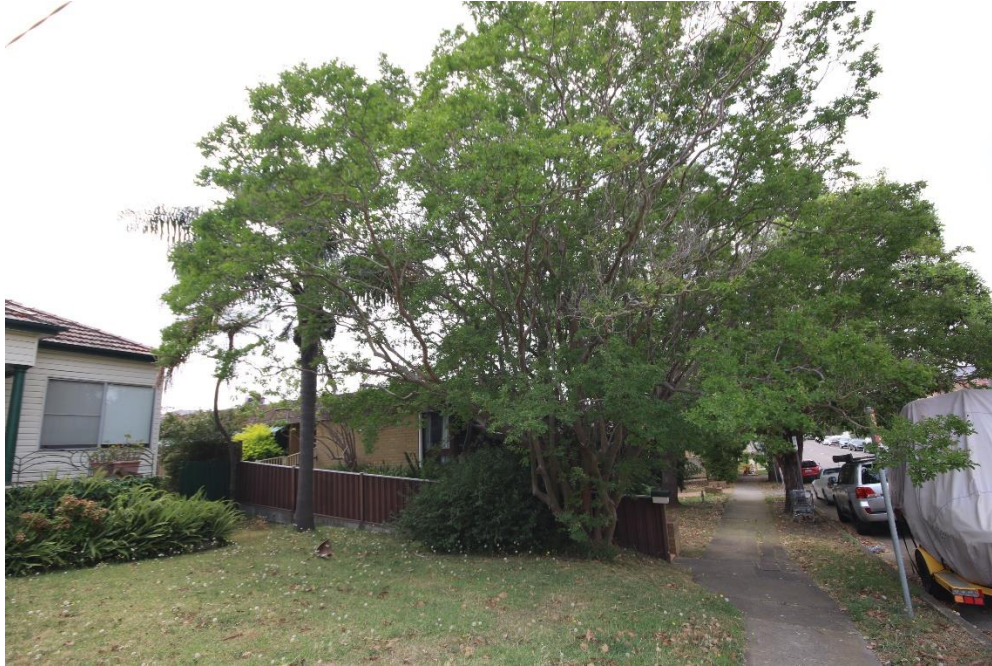
Plate 3 – trees 13, 12 & 11

6. Tree 11 *Lagerstroemia indica* shows good vitality with an elevated form – refer plate 3. This tree is within the driveway to the car parking area along Ethel Street – refer Annexure C. While it is in good vitality it should not be considered to be an impediment to constructing the driveway to the car parking as it can be easily replaced in the landscape works, maybe with a more appropriate species that is endemic to this area. Note for removal in the TMP;

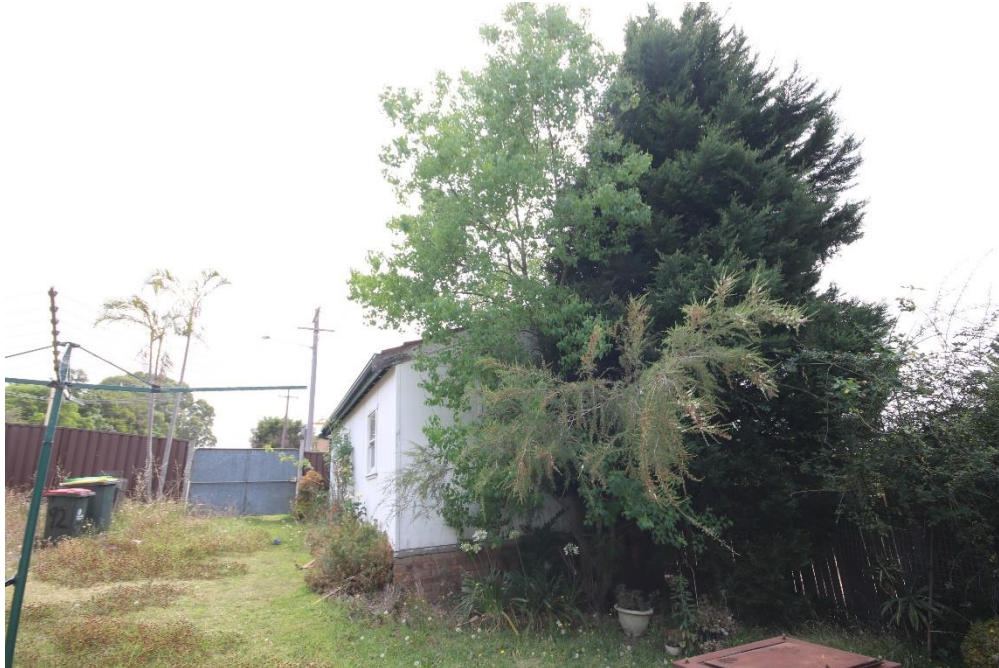
Plate 4 – trees 14, 15 & 16

7. Tree 13 *Cyathea australis*, tree 14 *Dypsis lutescens*, tree 15 *Cupressocyparis leylandii* and tree 16 *Triadica sebifera* are all within the proposed car park along Ethel Street – refer Annexure C & plate 4. To construct and excavate the car parking area, these trees will need to be removed. Neither of these trees are considered to be of high retention value and can be easily replaced in the landscape works with an endemic tree from this area. Note these trees for removal in the TMP.
