Structural REPORT
14-16 Victoria Street Kogarah

Project No: 19067-09

Revision: **03**

STRUCTURAL REPORT

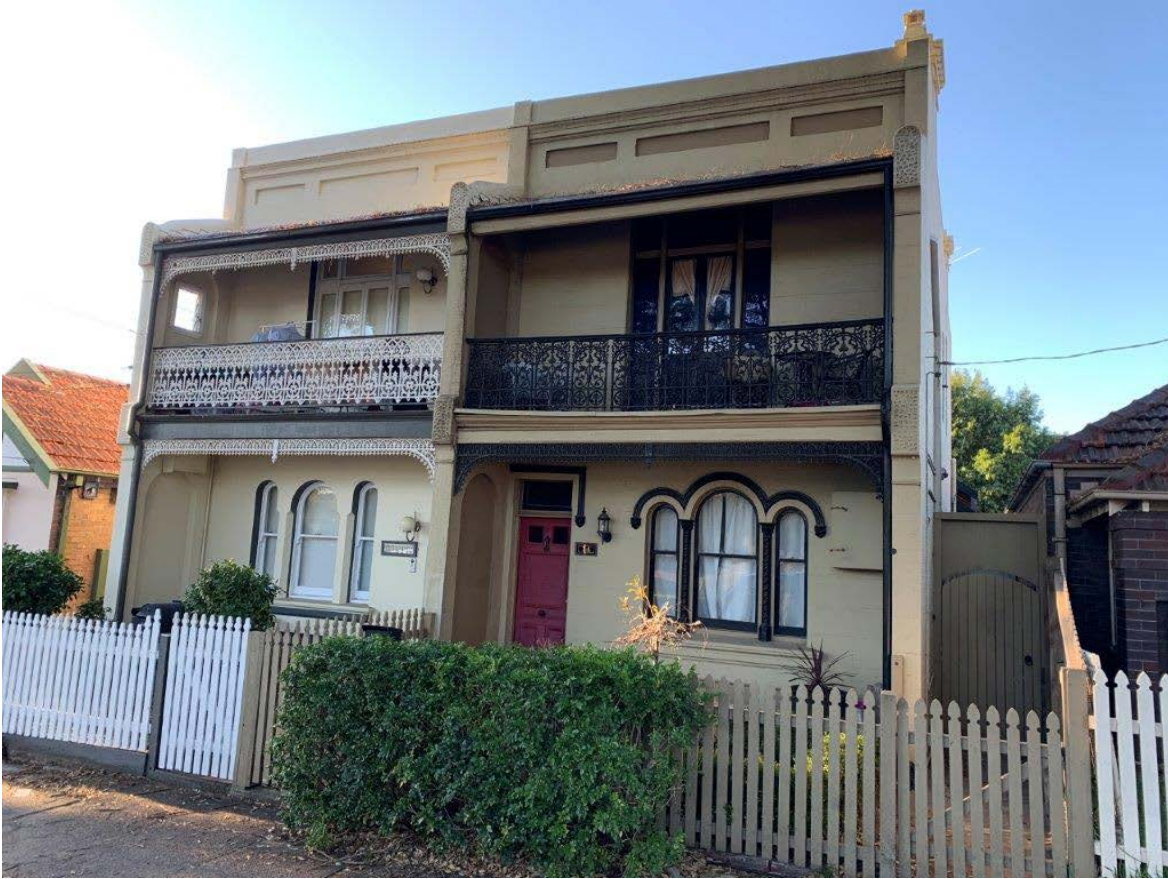
Photo 1 - Overall Photo of 14-16 Victoria Street (Sagging Balcony)

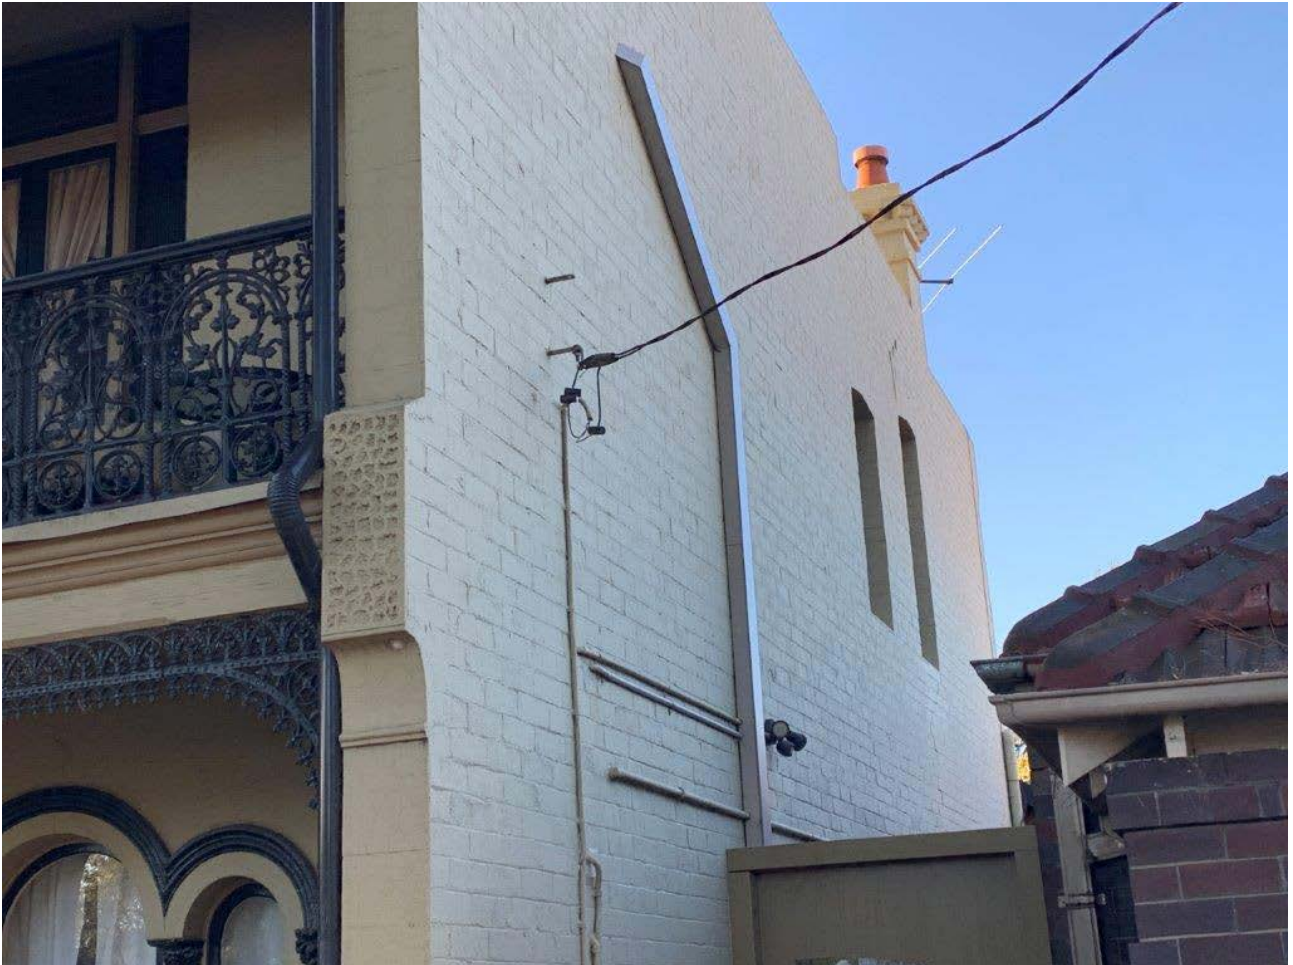
Photo 2 - Cracks in External Brick Wall at Terrace Number 14

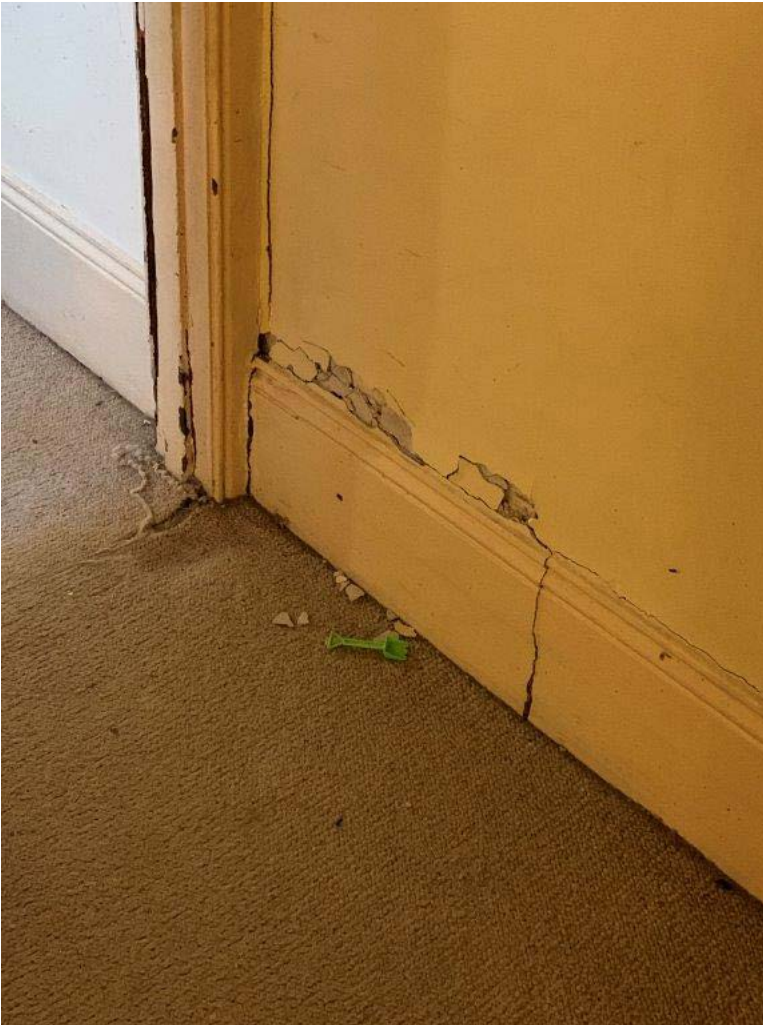
Photo 3 - Cracks in Brick Wall

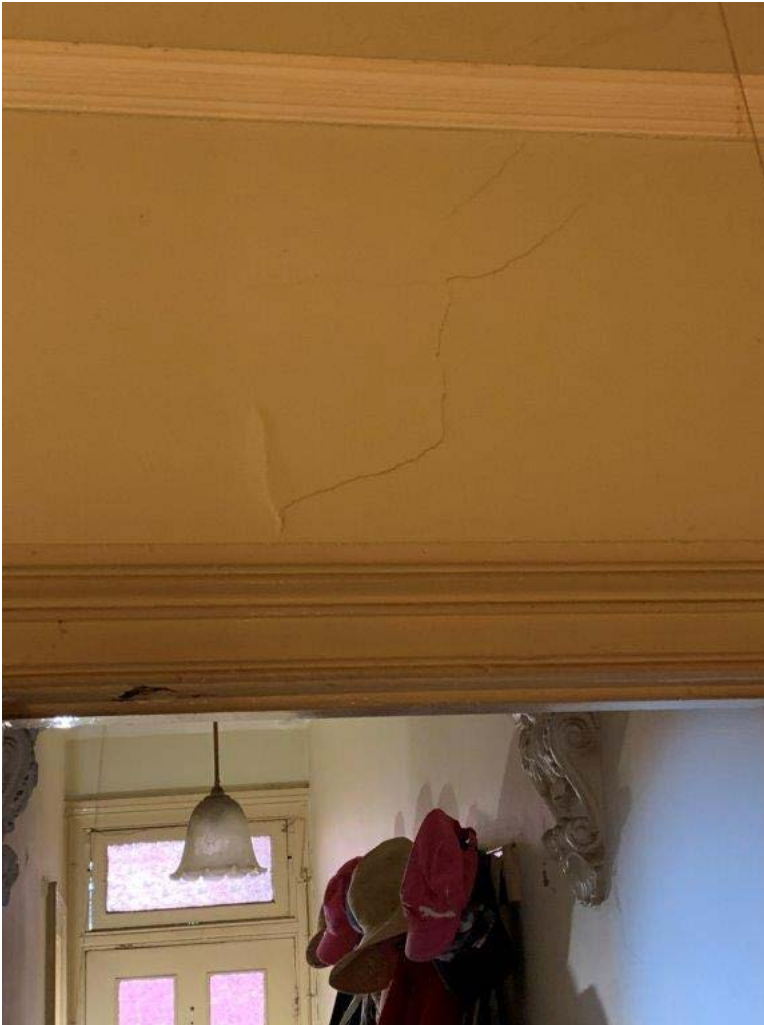
Photo 4 - Cracks in Brick Wall

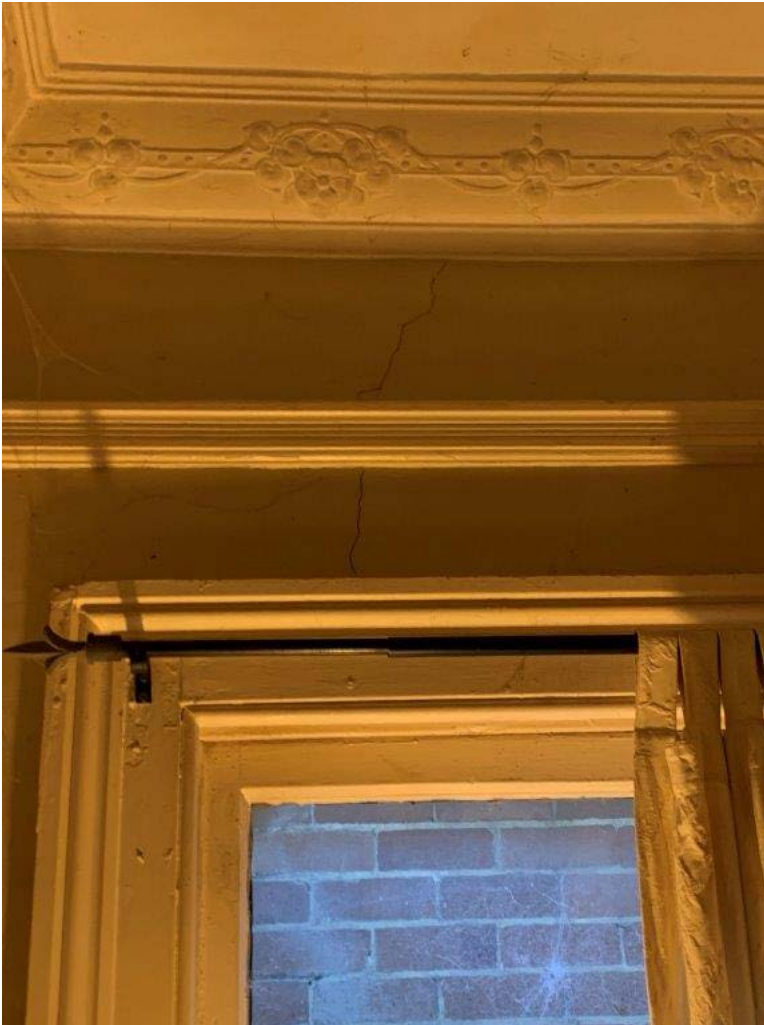
Photo 5 Cracks in Brick Wall

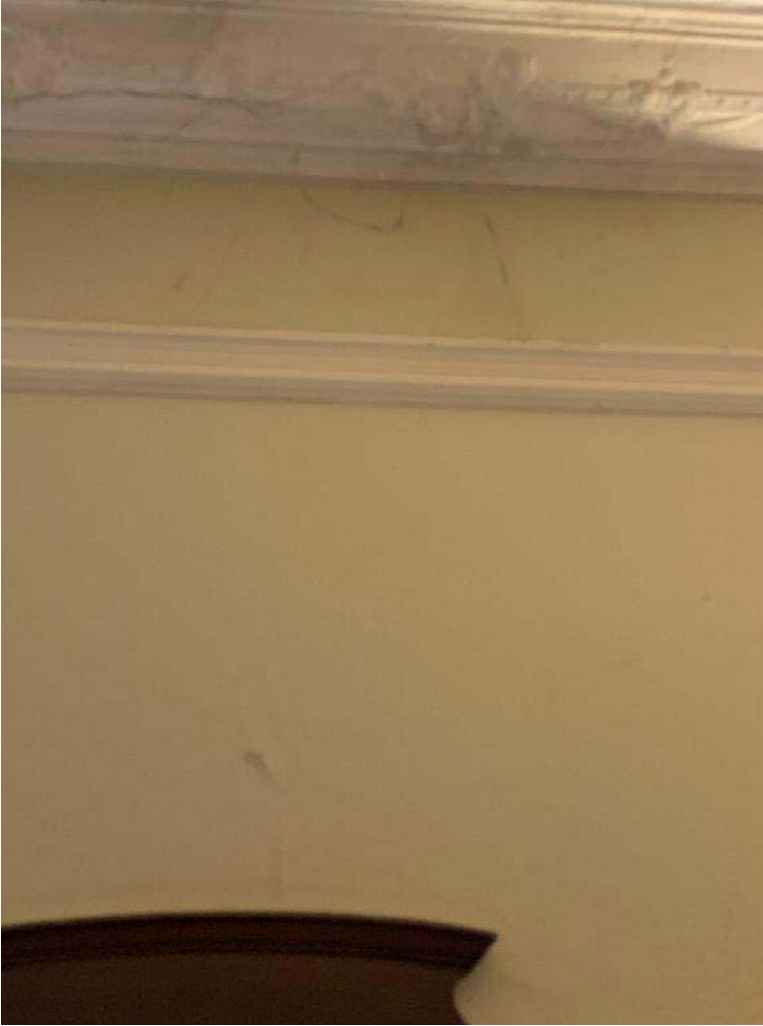
Photo 6 - Cracks in Brick Wall

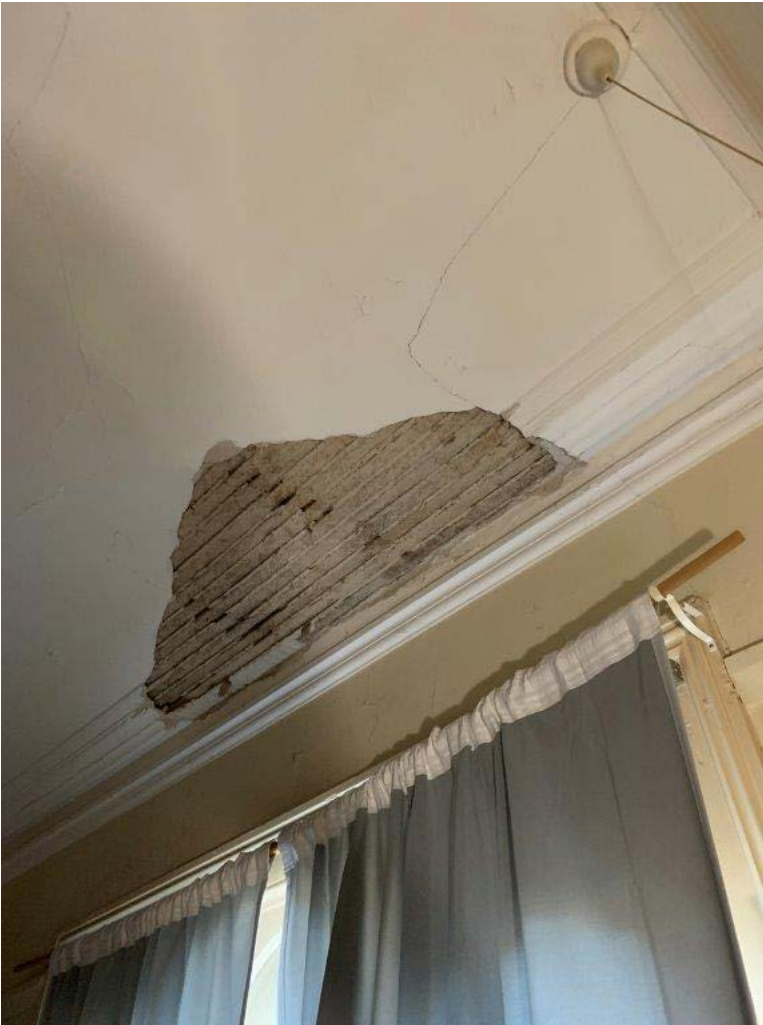
Photo 7 - Cracks in Ceiling and Brick Wall

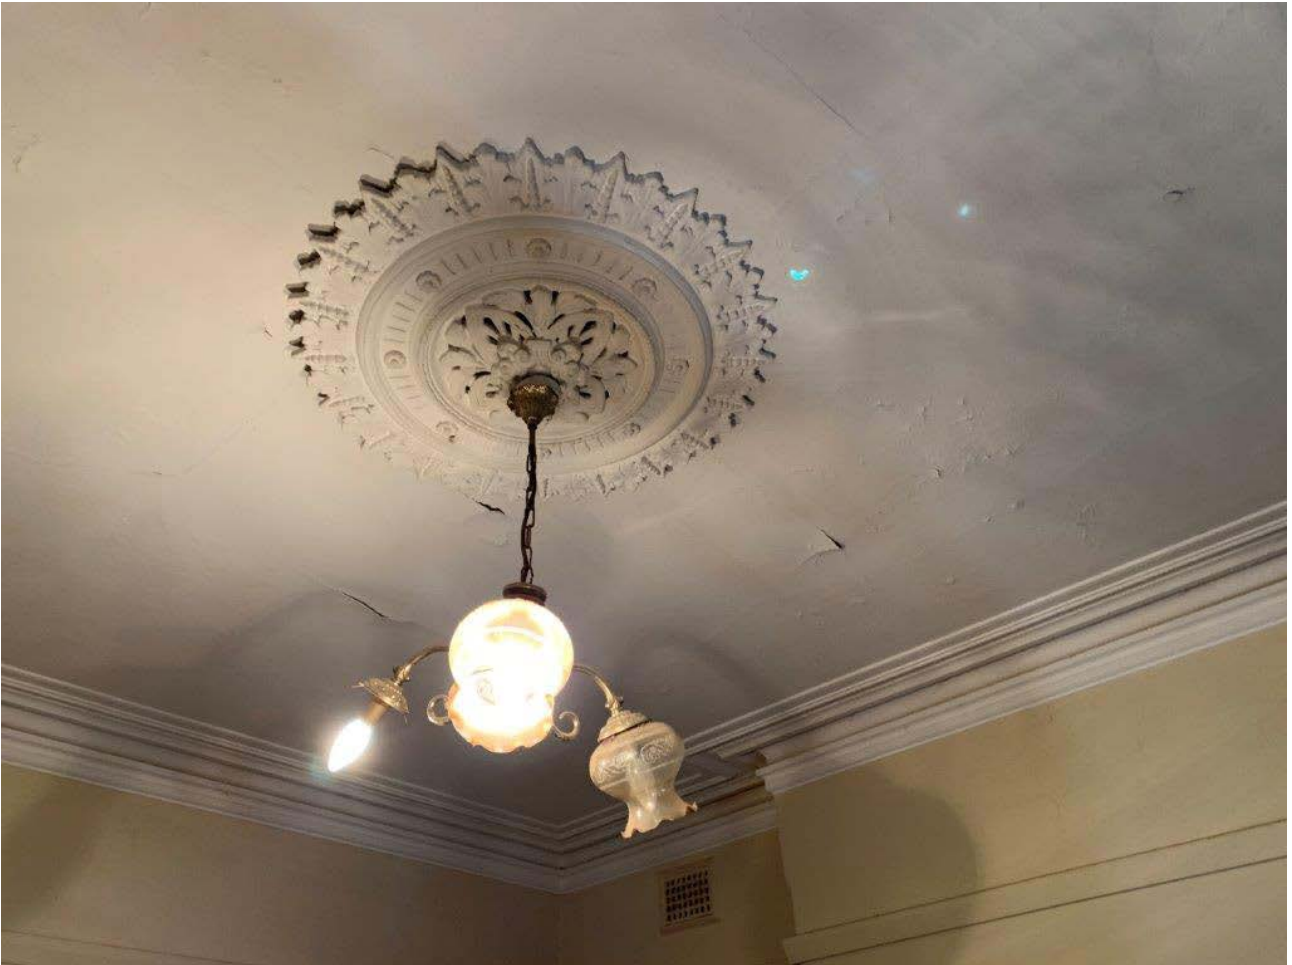
Photo 8 - Condition of Ceiling

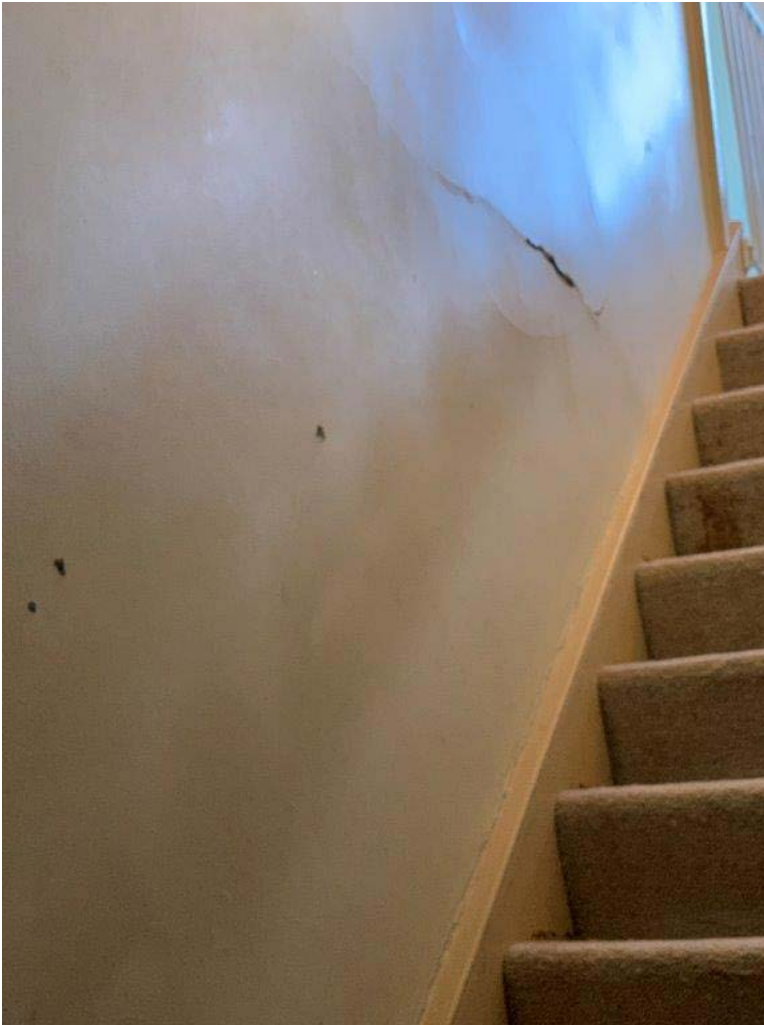
Photo 9 - Cracks in Brick Wall

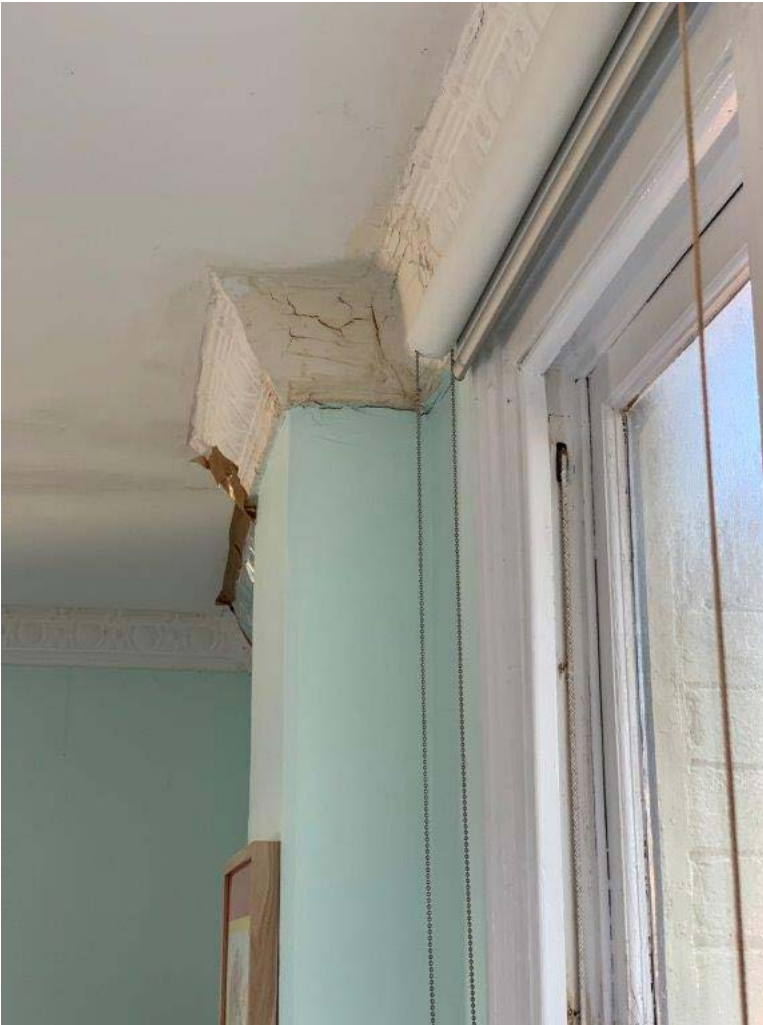
Photo 10 - Cracks in Brick Wall

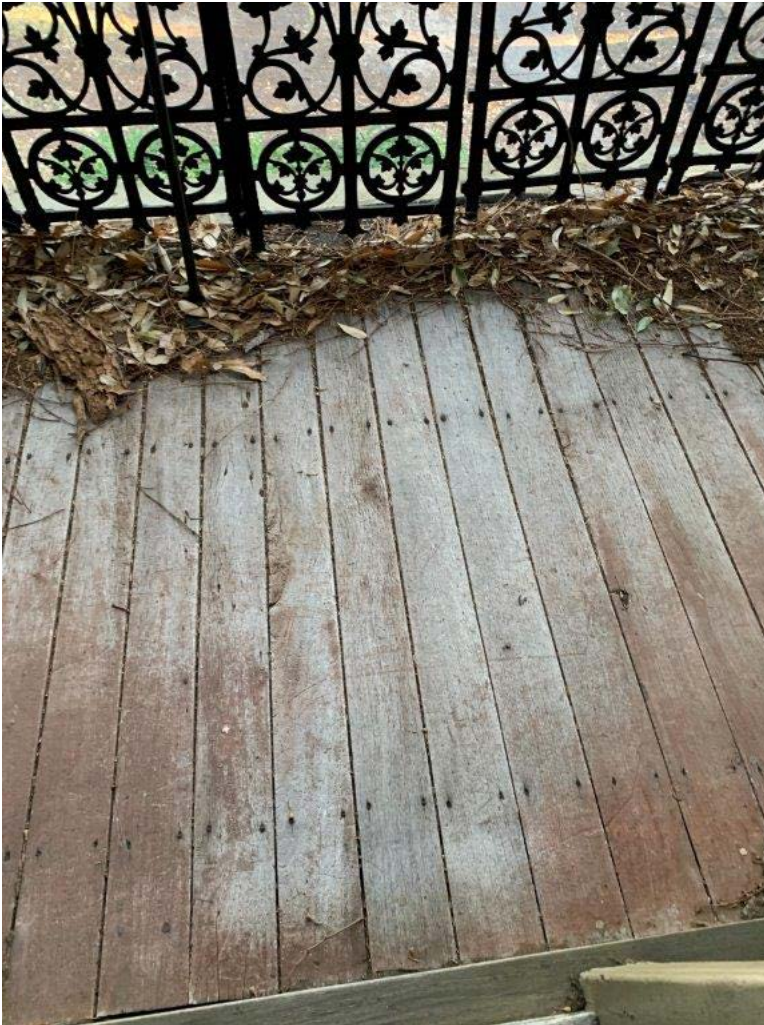
Photo 11 - Sagging Balcony

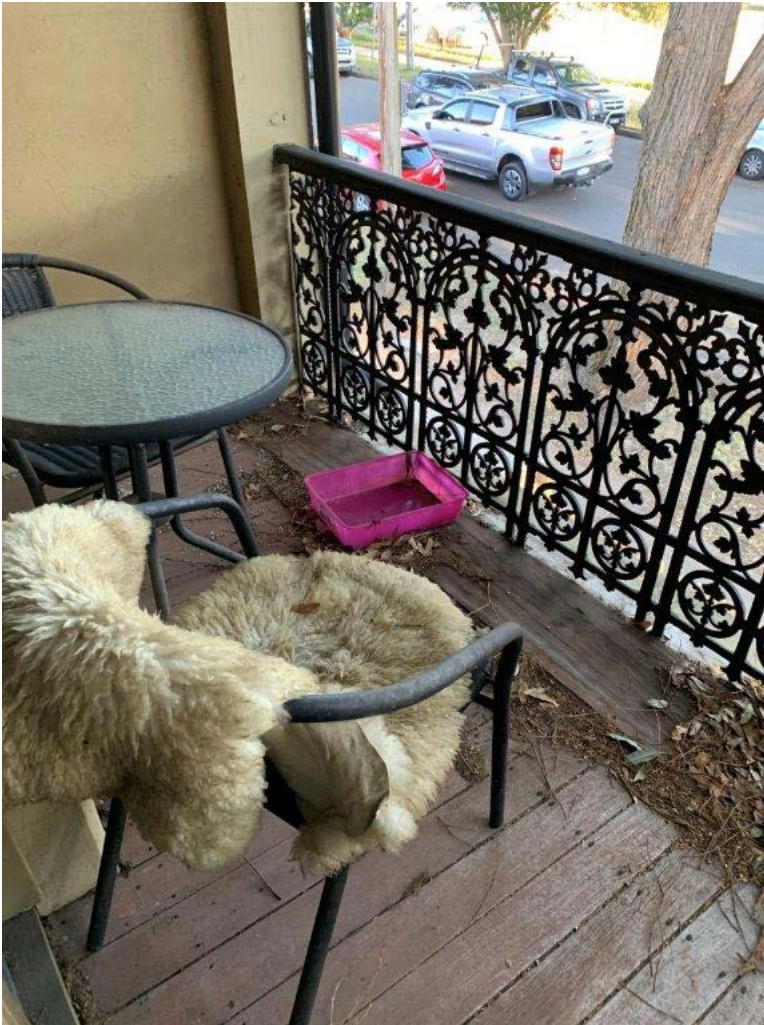
Photo 12 - Sagging Balcony

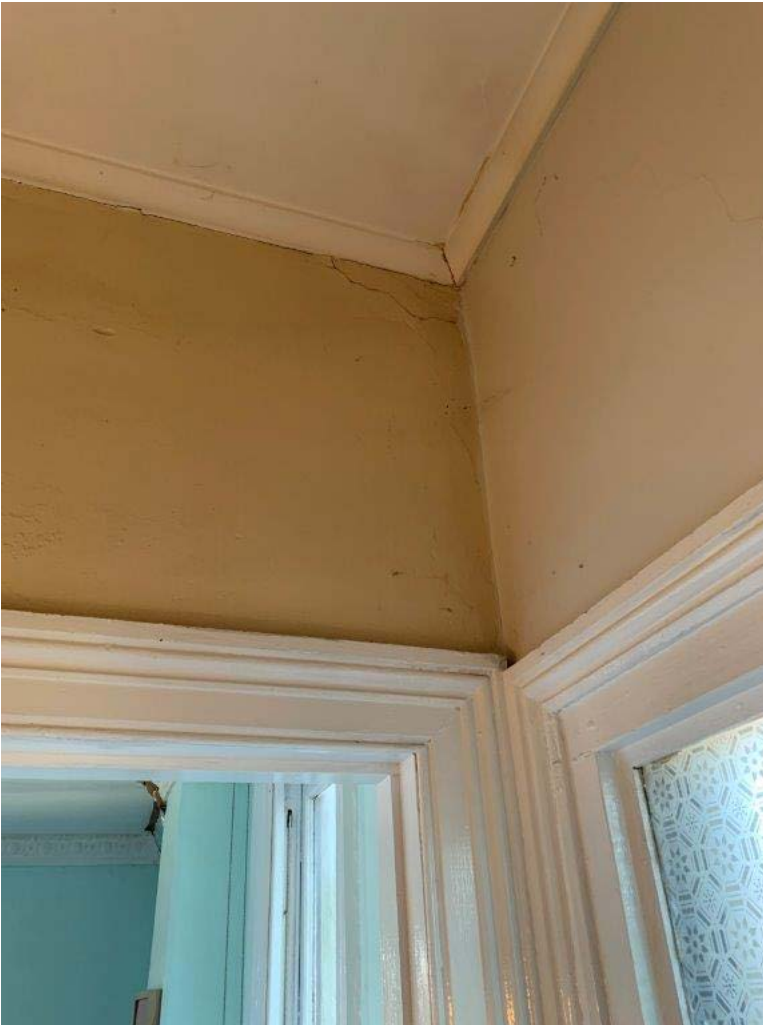
Photo 13 - Cracks in Brick Wall

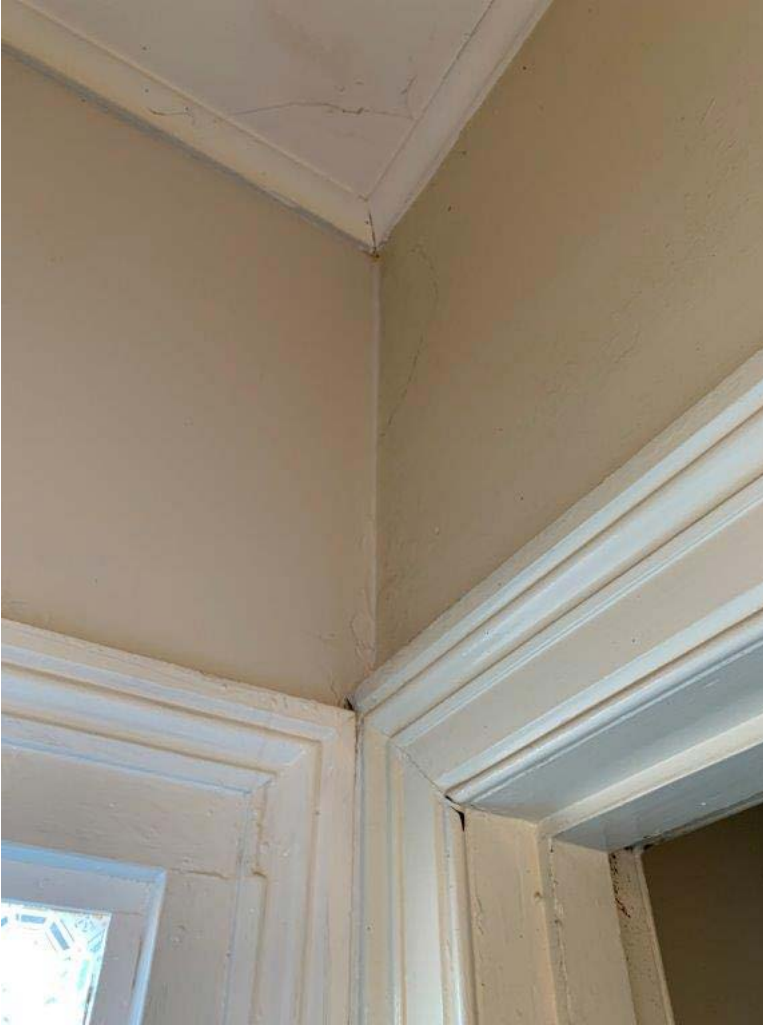
Photo 14 - Cracks in Brick Wall

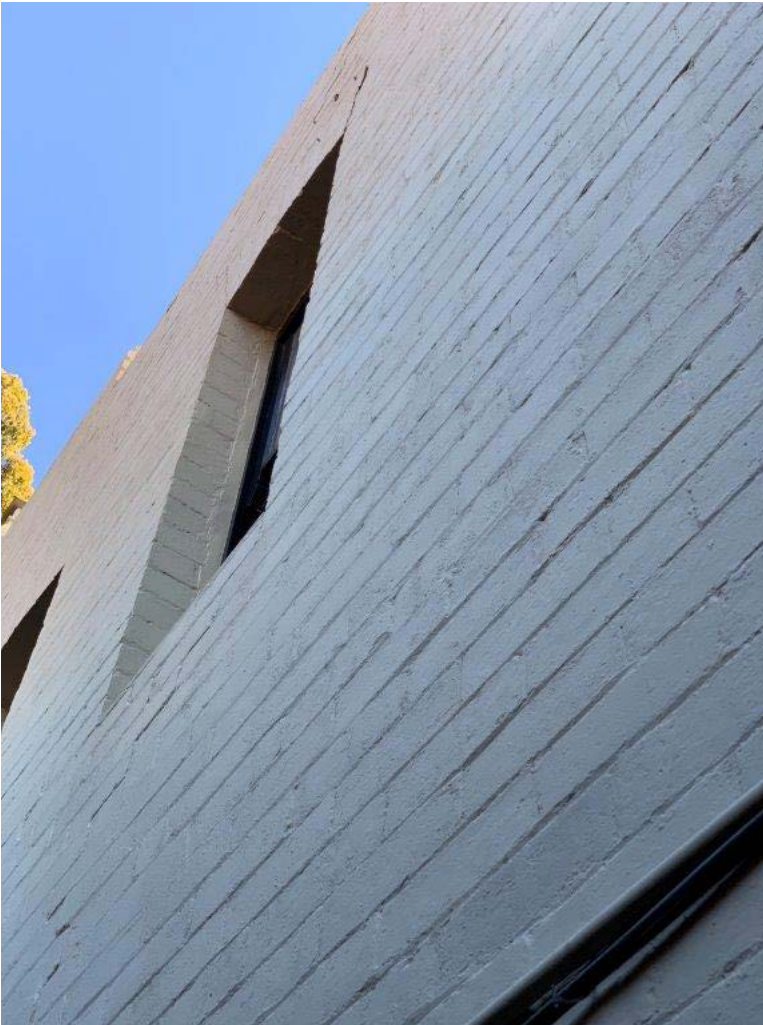
Photo 15 - Cracks in Brick Wall

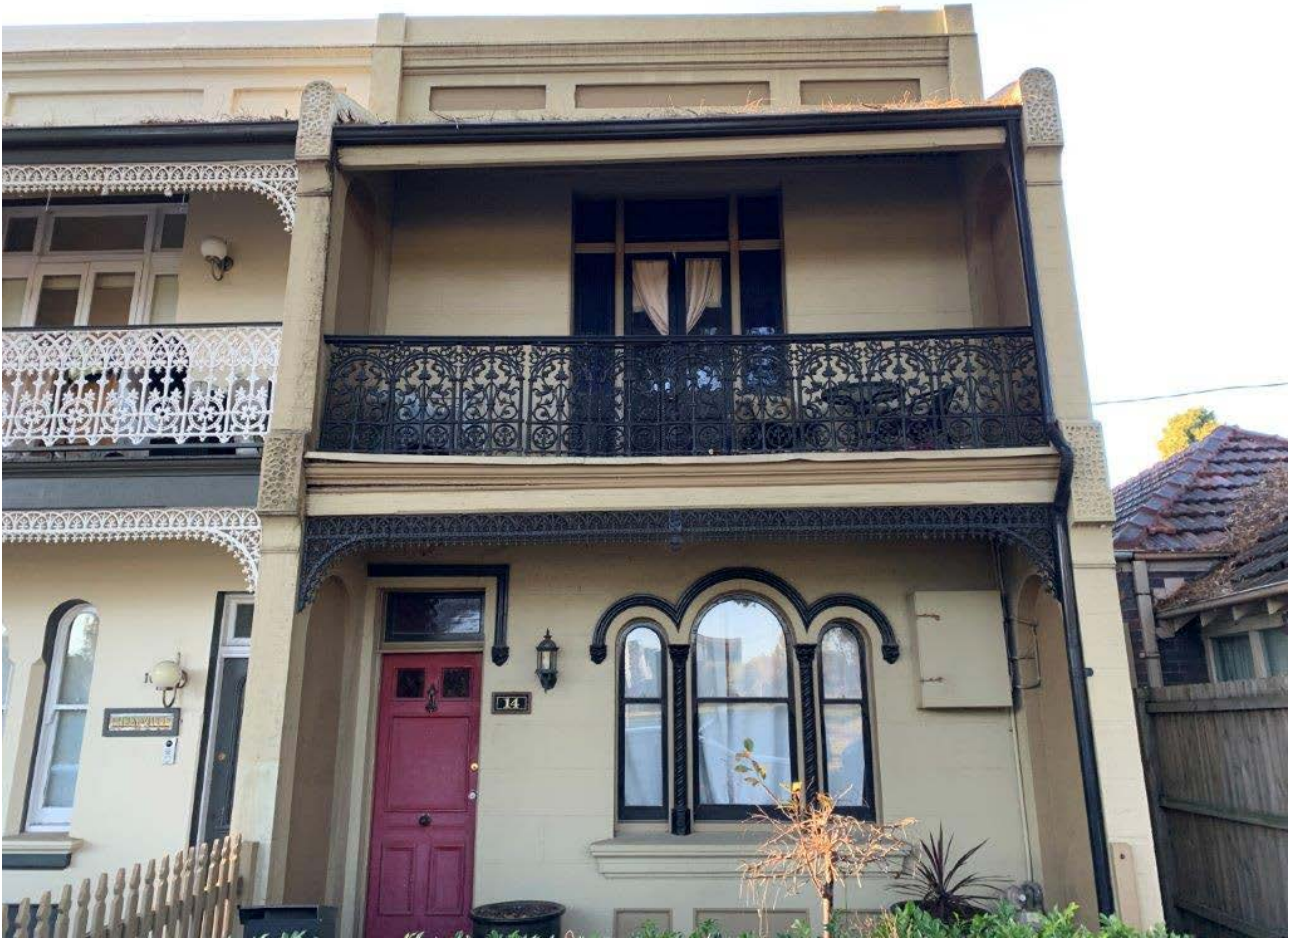
Photo 16 - Sagging Balcony

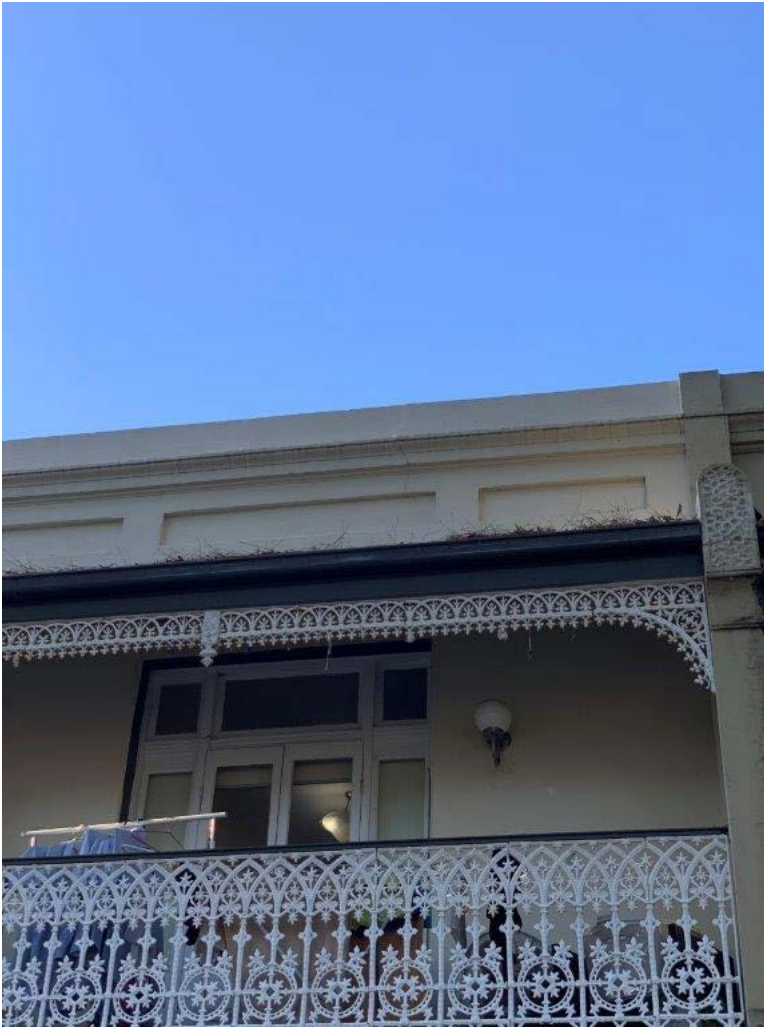
Photo 17 - Cracks in Brick Parapet at Terrace Number 16
