# 90-92 BOTANY STREET, CARLTON

## Light Spill Assessment

SLR Ref: 610.30096-R01  
Version No: -v1.0  
September 2020

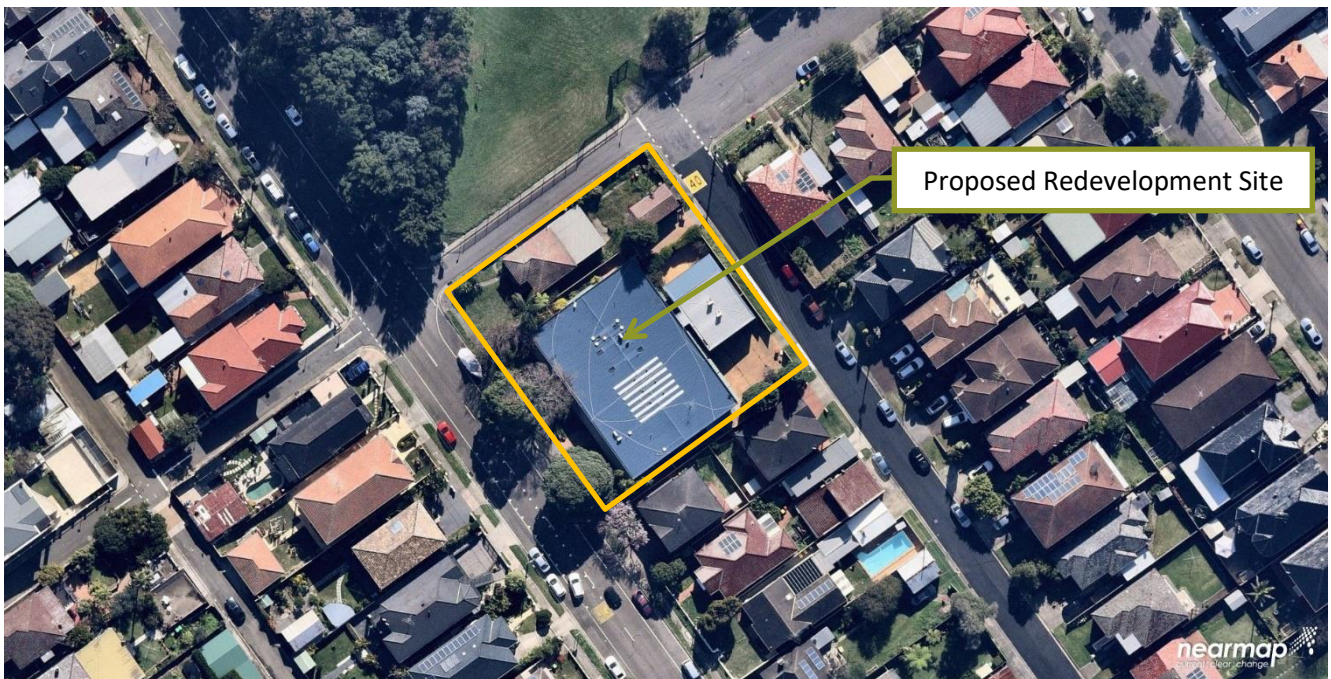
**Figure 1** Aerial Image of the Site Location

The site is located on the corners of Botany Road, Ethel Lane and Xenia Avenue an approximately 800 metres from Allawah Station.

Image: Nearmap (August 2020)

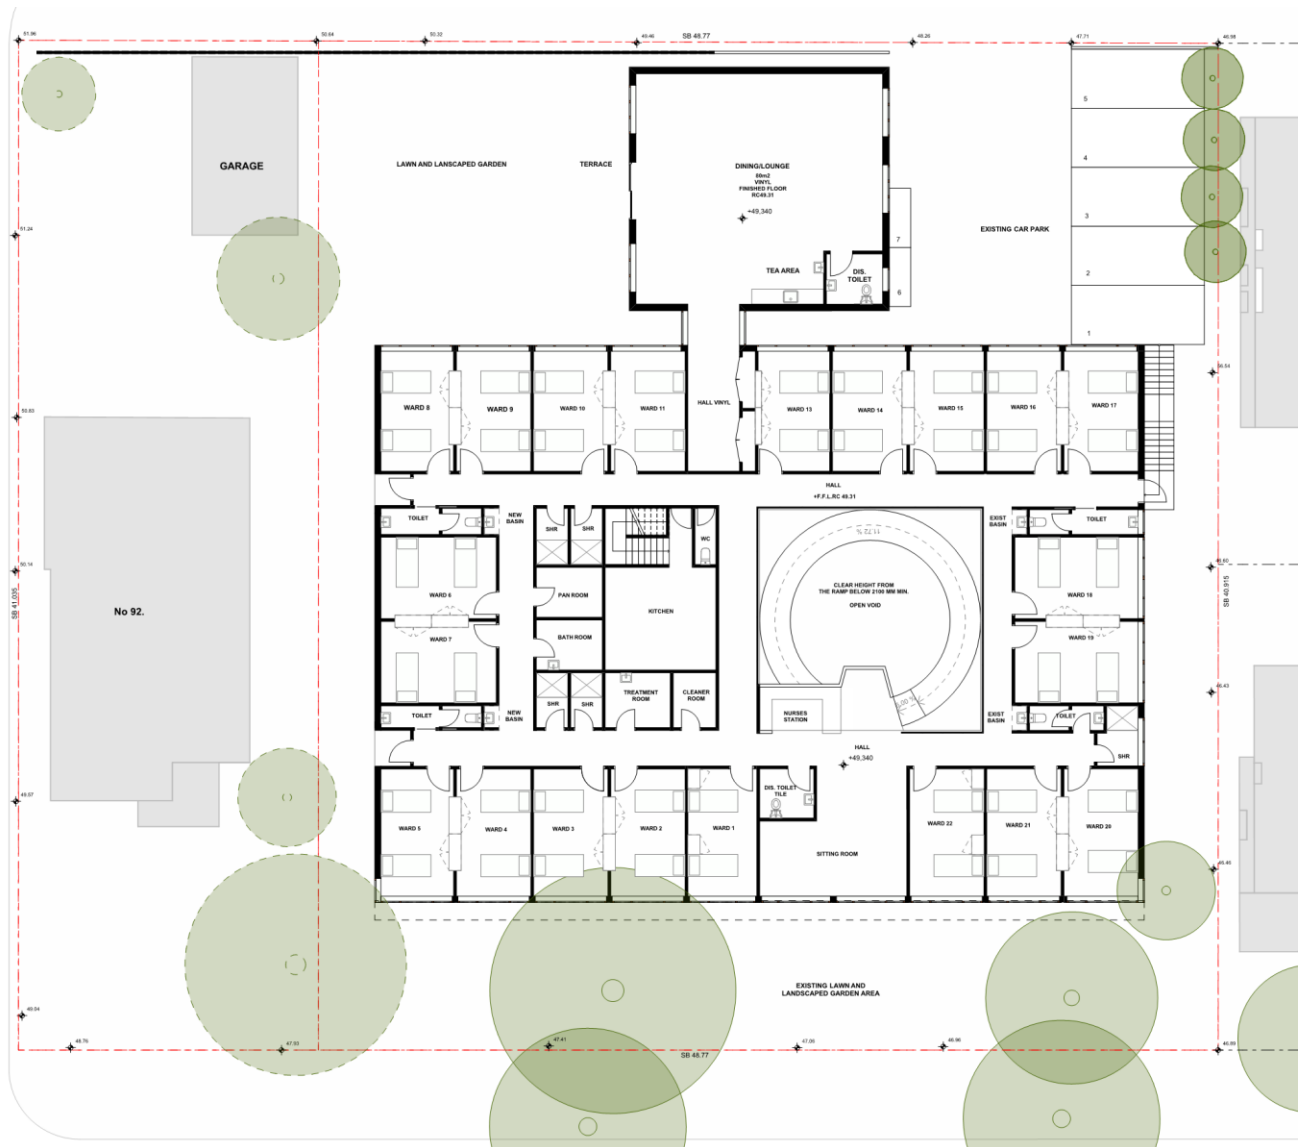
Figure 2 Existing

SLR has been asked to SLR have been asked to assess the light spill from the proposed site. The site currently contains a residential aged care facility which is no longer in operation and a single dwelling on the neighbouring lot to the north. The proposed redevelopment is for a public place of worship which will involve alterations to the aged care facility and demolition of the single dwelling.

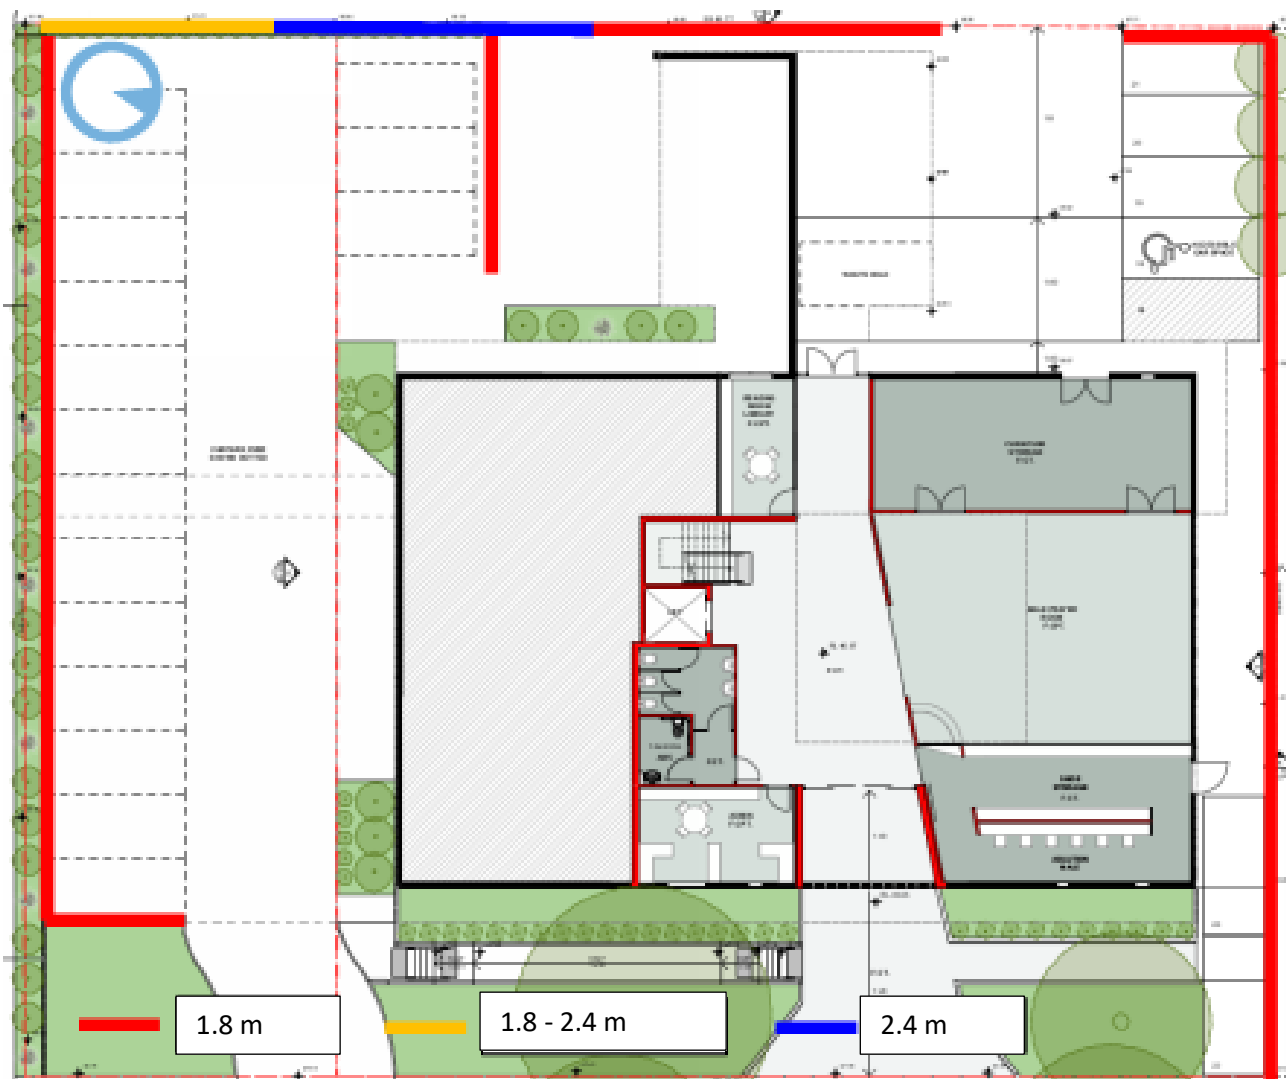
Figure 4 Mitigation Measures

The acoustic report for the site recommended the fence height shown in the figure below. This will also have a positive impact by containing light spill to the site in particular light coming from vehicle headlights

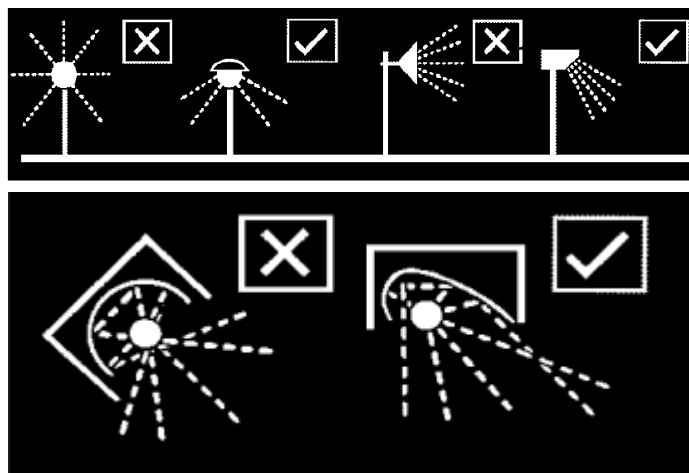
**Figure 5** Minimise Light Spill

- Direct lights downward as much as possible.
- Use luminaires that are aimed to minimise light spill, e.g. full cut off luminaires where no light is emitted above the horizontal plane. Less spill light means that more of the light output can be used to illuminate the area and a lower power output can be used. The energy consumption for the fitting can thus be reduced without decreasing the illuminance of the area. Refer **Figure 5**.
